Condition Assessment Report

CTF - Bldg A
3500 Pennsy Drive
Hyattsville, MD 20785

Inspection Date: Thursday, June 12, 2014

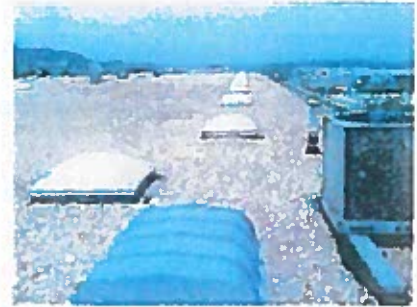
Roof Condition Score: 53 (Unsatisfactory)

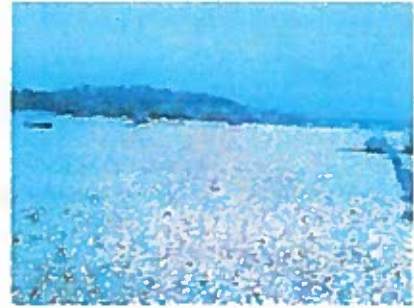
Roof Condition Score: 42 (Unsatisfactory)

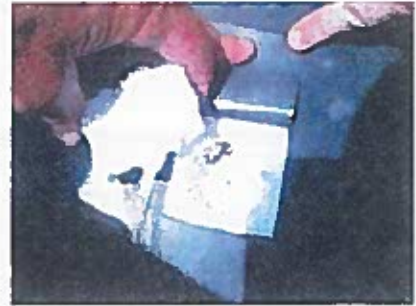
Photo

Core test
45 mil EPDM, 2.5" EPS, metal deck.

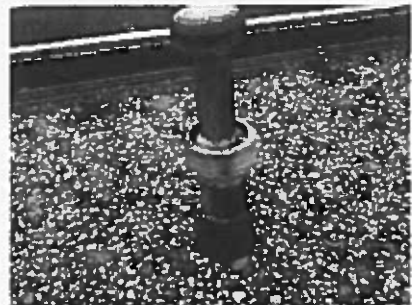
Associated Defect: #6 - Flashing damage or deterioration (EA)

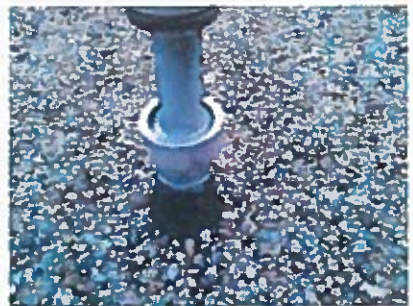
Associated Defect: #11 - Flashed penetration defects

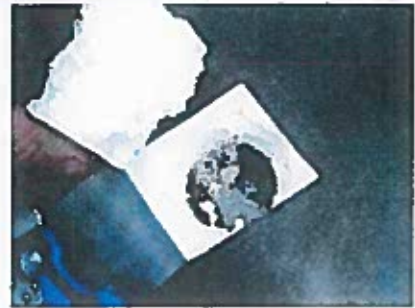
Photo

Core test
45 mil ballasted EPDM, , 2.5" EPS, metal deck.

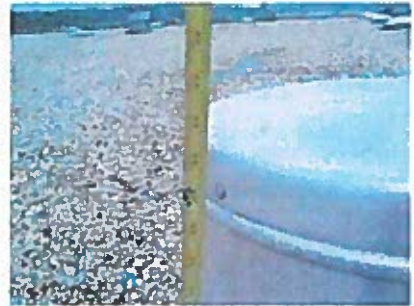
- Support: Curbed
- Type: Mechanized
- Base height: 12"
- Length: 2'
- Width: 2'
- Unit height: 2'

Associated Defect: #27 , #28 - Flashing damage or deterioration (EA)

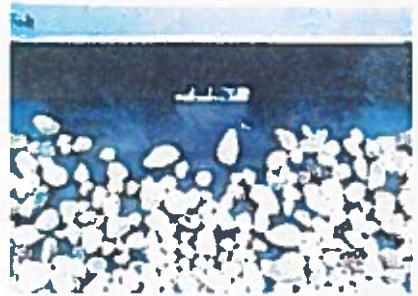
Overflow scupper

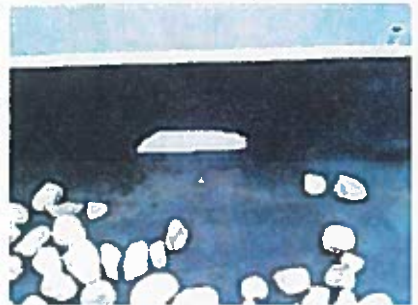
Overflow scupper

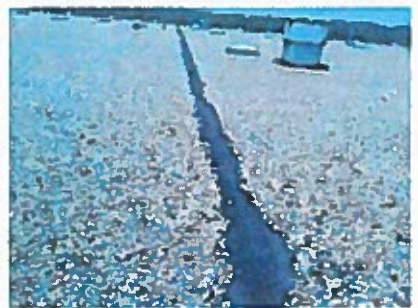
Segment (interior)

• Type: Joint
