Condition Assessment Report

C94 Alexandria Yard Revenue Collection Facility
3301 Eisenhower Avenue
Alexandria, VA 22314

Inspection Date: Friday, June 20, 2014

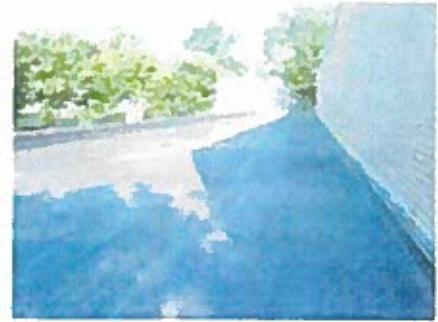
Section ID: A

Roof Condition Score: 80 (Degraded)

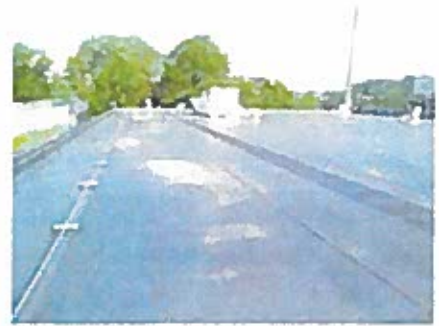
Section ID: B

Roof Condition Score: 55 (Unsatisfactory)
